# Detection Of Sliding Plane as A Disaster Mitigation Efforts In The Pengembur Village, Pujut Sub District, Central Lombok Regency

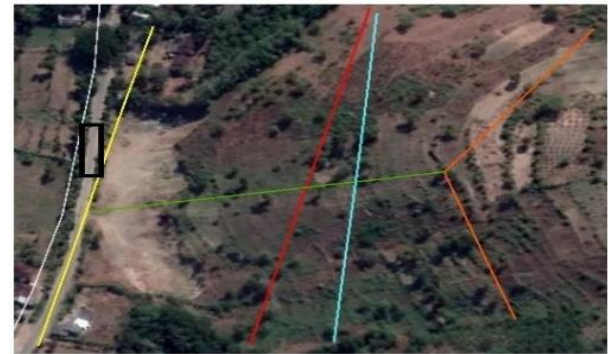
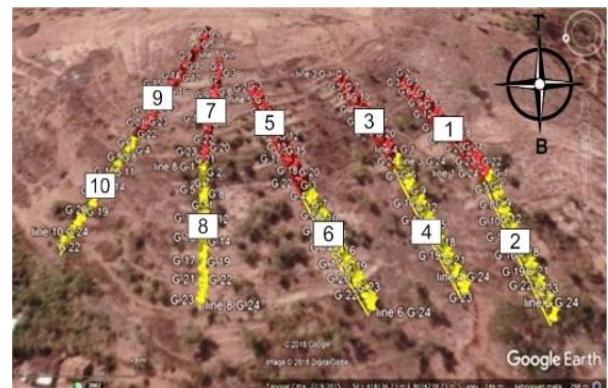
Figure 2 (a). Lines of geoelectrical method measurement, (b) Lines of ReMi method measurement

The measurement with the Geoelectric method is done on 6 lines and the ReMi method is 10 lines as shown in Figure 2. The coordinate position of each can be seen in Appendix 1.

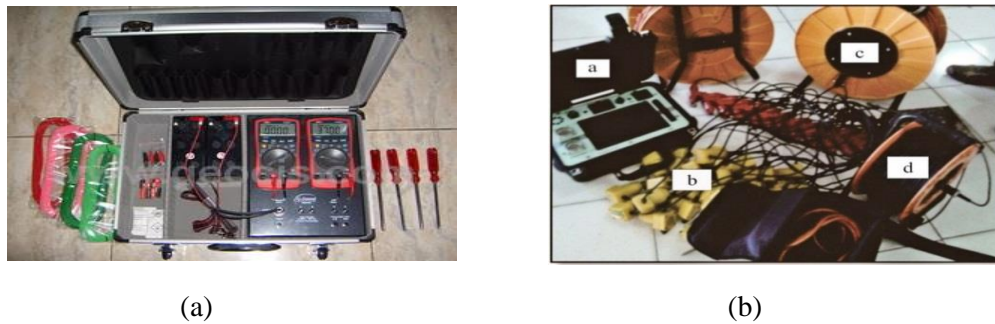
Figure 3. (a) G-Sound 4200 type Resistivitymeter [9]; (b) 24-channel PASI Seismometer [10]

Geoelectric measurements use 1 set of G-Sound Resistivitymeter 4200 and for seismic measurement using a 24-channel PASI Seimometer (Figure 3). This research uses two simultaneous methods of geophysical, and data from both methods as materials for the analysis of the sliding plane and landslides in the research area. The research implementation stages are shown in Figure 4 below:

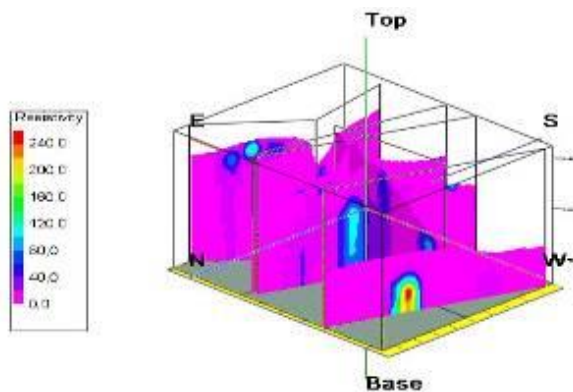
Figure 6. The results of vertical slicing of a solid 3D model appear from the north-west direction

The 3D visualization, as shown in Figure 6 and Figure 7, is a 3D picture of dat gelistrik interpretation of 2D. This visualization is intended to give you an idea to give the distribution of rocks and the position of the sliding plane in the area of study.

Figures 6 and 7 show that the sliding plane is marked with a black box and were photographed with blue, red and yellow are in each path and spread from the East to the West. Based on the results of a solid data model, geological layers obtained research area based on litologi each trajectory looks North – West, as shown by Figure 8.

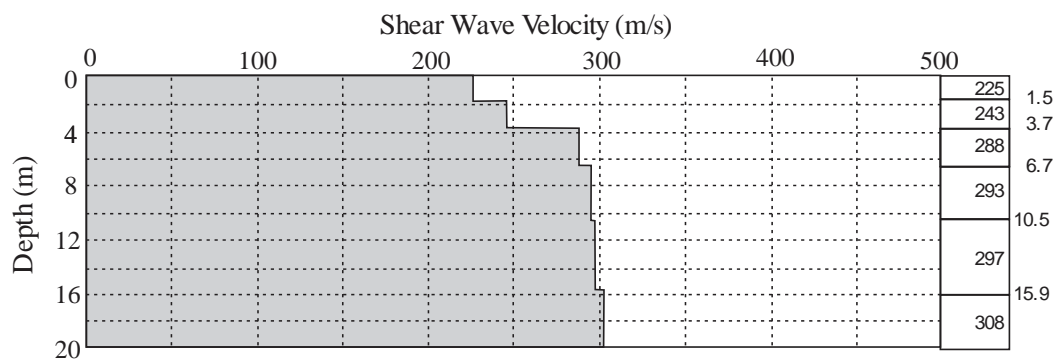
Figure 9. Shear Wave Velocity profile on the seismic line - 3

The lithology determination of the study area is also based on the value of the shear wave velocity, so that the thickness of the layer that is potentially prone to landslides is known. The results of data interpretation in the form of shear wave velocity profiles, as shown in Figure 9 and Figure 10, are shear wave velocity profiles on seismic line - 3 and 4. The results of interpretation of subsurface rock lithology based on the value of the shear wave velocity are shown in Table 2.

On seismic line 3, there is a layer of rocks that is a layer of soil is being alleged in the form of deposits of semi-solid sand, gravel, solid clay, sand, water saturated sand, and unconsolidated sand. This layer has a thickness of 20 meters. Although type of soil layers are the same, but there is a difference of shear wave velocity variation value. Velocity has increasingly as a function of depth, this happens because of the deeper soil layers has more of compactness or more solid.

Line	Layer	Layer thickness (m)	$v_s$ (m/s)	% error	Type of Rock	Sediment
3	1	1,5	225	0,08	medium soil	Sand deposit and semi solid, gravel, solid clay, water saturated sand, unconsolidated sand
	2	2,2	243			
	3	3	288			
	4	3,8	293			
	5	5,4	297			
	6	4,1	308			
4	1	1,5	93	0,54	Soft soil	soft clay, sand saturated by water, unconsolidated sand
	2	2,2	188		medium soil	Sand deposit semi solid, gravel, solid clay, sand saturated by water, unconsolidated sand

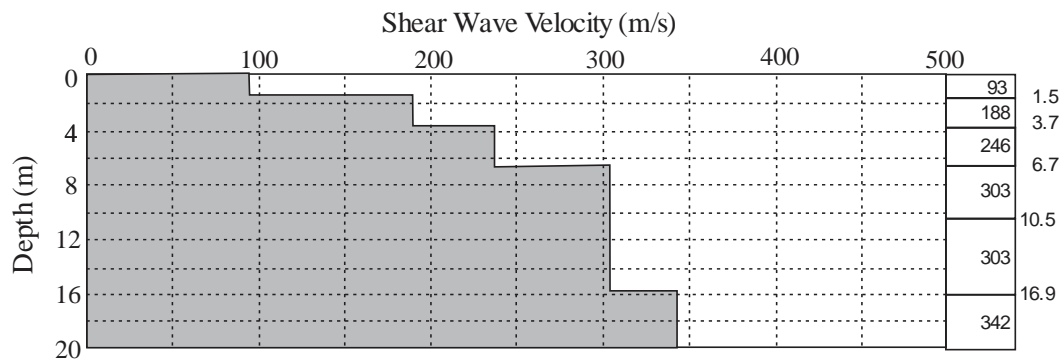
Figure 10. Shear Wave Velocity profile on the seismic line - 4

There are two layers of rock on seismic line 4, that is soft soil layers and layers of medium soil. The first layer of soft soil that is allegedly in the form

of deposits of low to medium cohesive soils, soft clay, water saturated sand, and unconsolidated sand. A second layer of soil that is being alleged to consist of sand deposits and a semi solid, gravel, solid clay, water saturated sand, and unconsolidated sand. A similar layer found in the seismic line 5, 6, 7, 9, and 10.

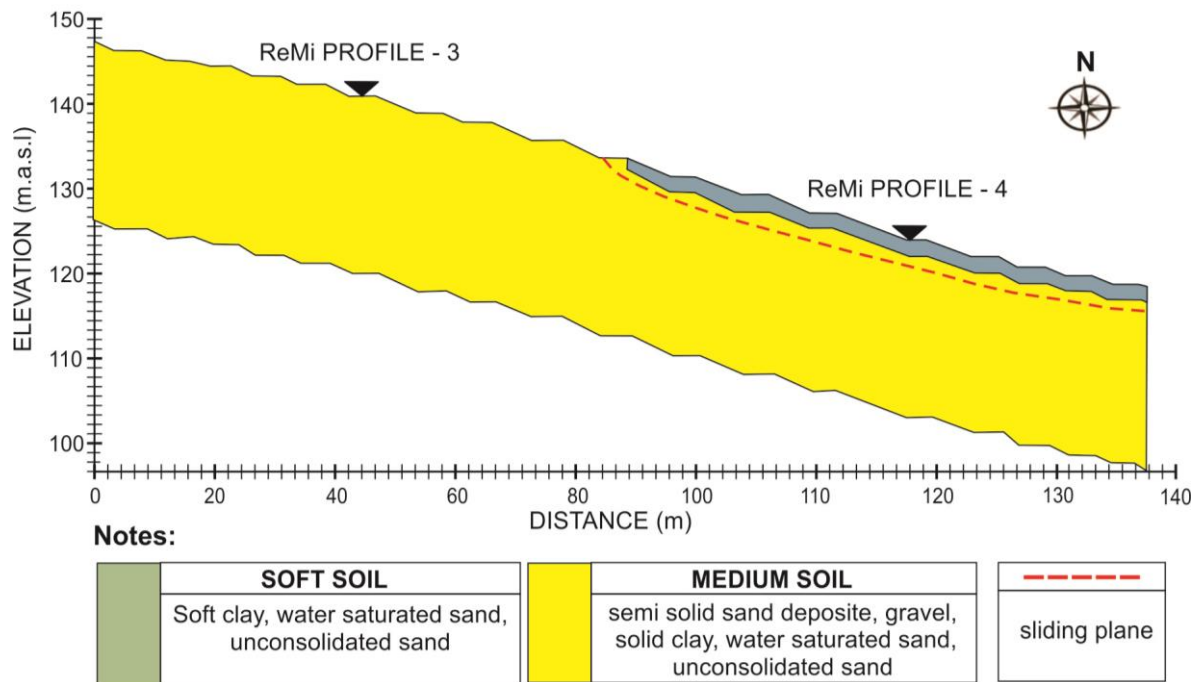
Figure 11. Interpretations of cross section of rock based on shear wave velocity profile on lines 3 and 4 which has a slope of  $11.6^\circ$

To illustrate and interpret the fields and material landslides, correlations are made between the lines as shown in Figure 11.

Figure 11 shows that there is a potential for landslides in the study area as indicated by the results of identification of soft soil layers which are prone to landslides and are associated with factors causing landslides at the study site. Estimation of soft soil lithology which is a layer of landslide prone which is suspected to consist of low to moderate cohesion sediments, soft clay soil, water saturated sand, and unconsolidated sand. This soft soil layer is loose so that the sloping area of this layer will become sliding material. With the existence of low cohesion soil, the water can penetrate until the impermeable soil (medium soil) which later will act as a sliding plane, the soil becomes slippery and soft soil above which acts as a landslide material will move to follow the slope due to gravity and coupled with the factor of high rainfall in the study area that occurred in December to March.

From the results of the interpretation of rock layers and slope, landslides that can occur at this research site are translation slides that occur on slides which are almost straight and parallel to the face of the land which can be seen in the cross-section interpretation of landslide-prone rock layers. This type of avalanche is expected to occur at each measurement of seismic line. However, of the ten seismic lines that have a negative impact in the event of a landslide is lane 9 and 10 that lead from east to west because there are settlements below the slope.
